Situation Photo Log

Thursday, August 16, 2012

Kalamazoo River / Enbridge Spill

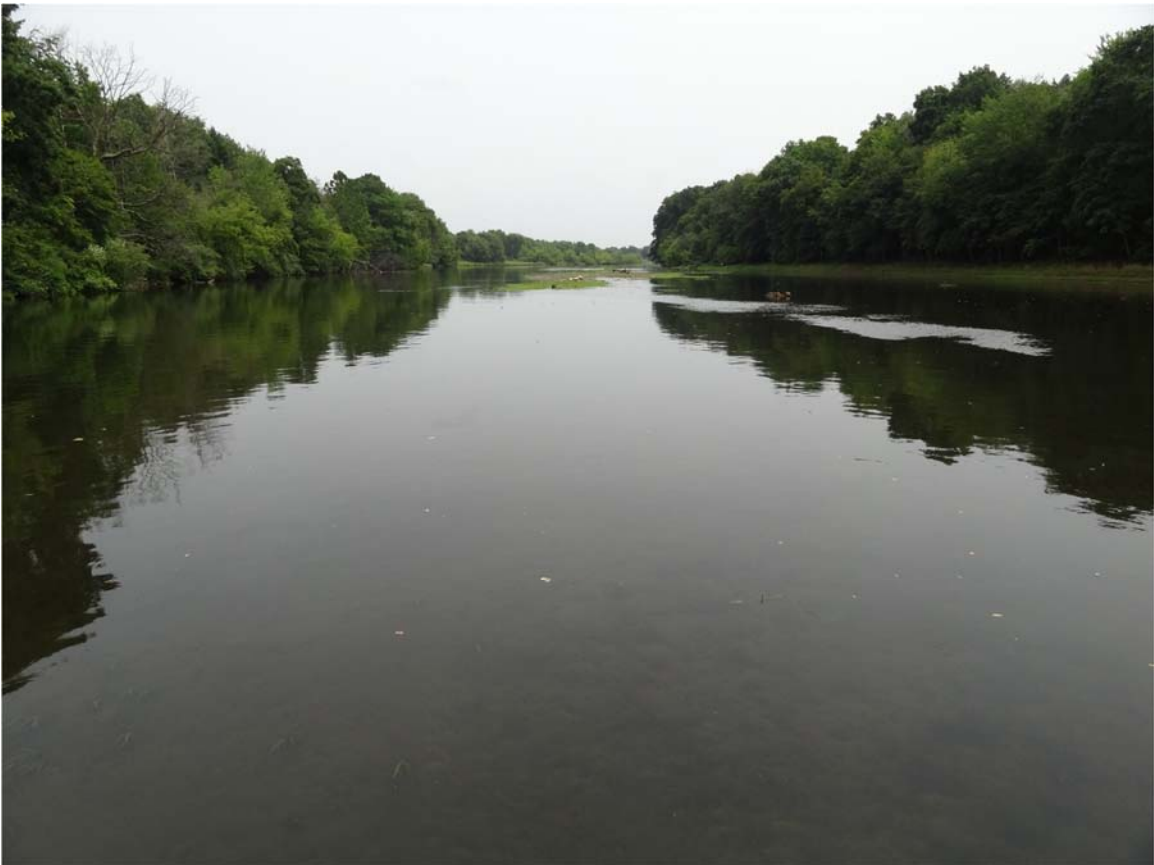
24. MP4.5 just down from the former Island F observed sheen.

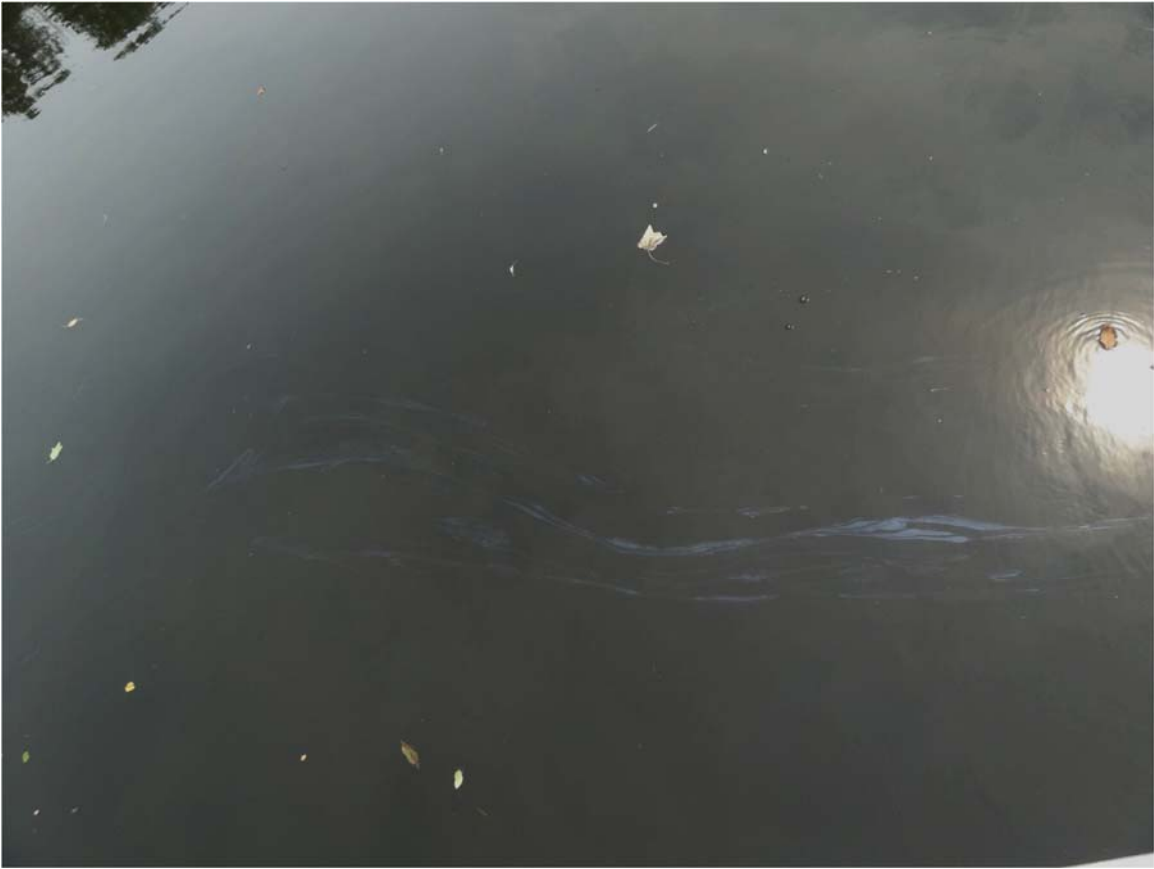
25. MP4.5 just down from the former Island F observed sheen.

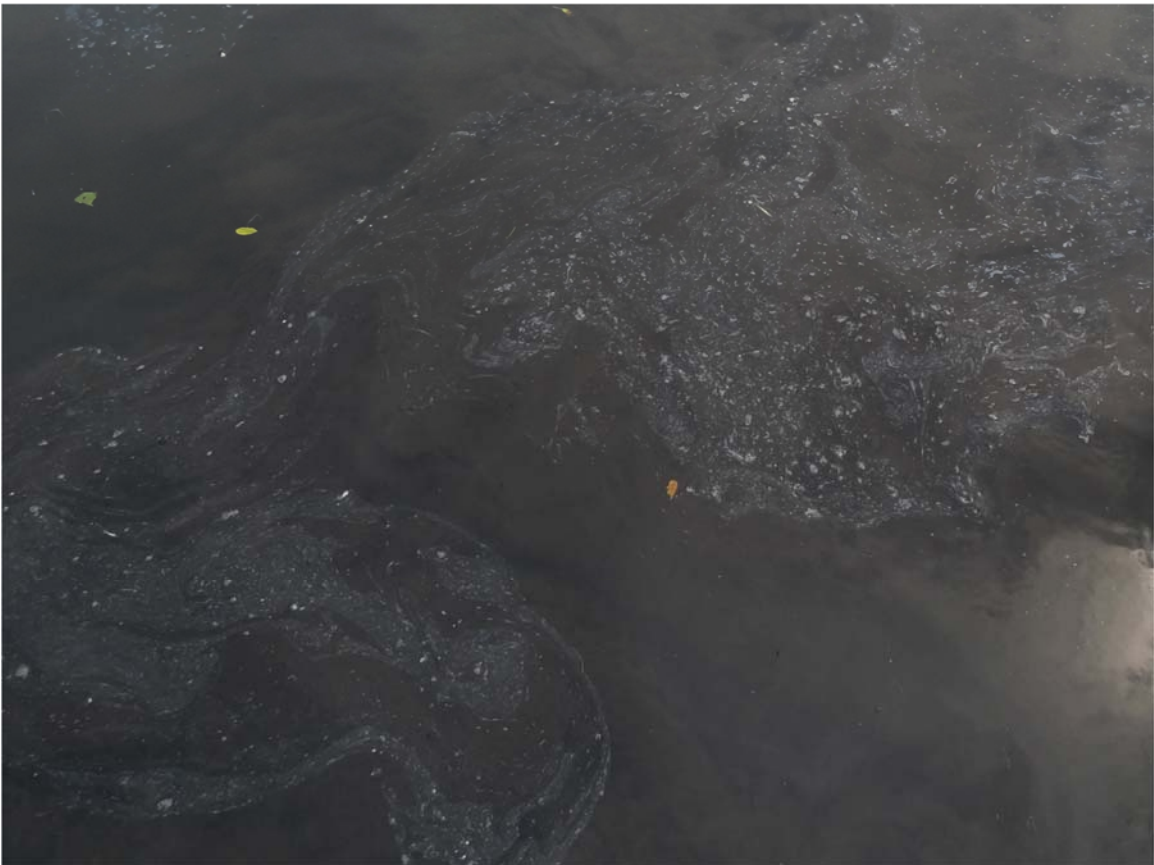
26. MP4.5 just down from the former Island F observed sheen when the boat reversed out of the area.

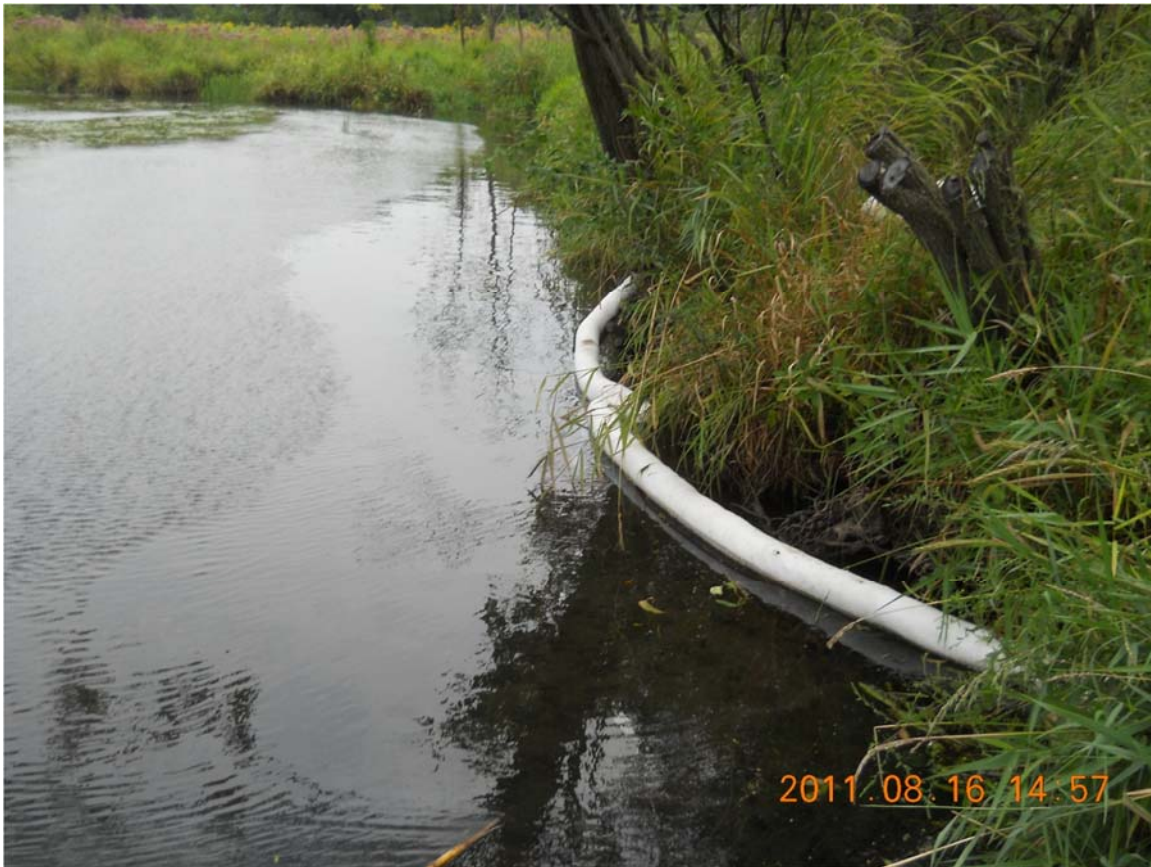
27. MP10.75 sheen observed.

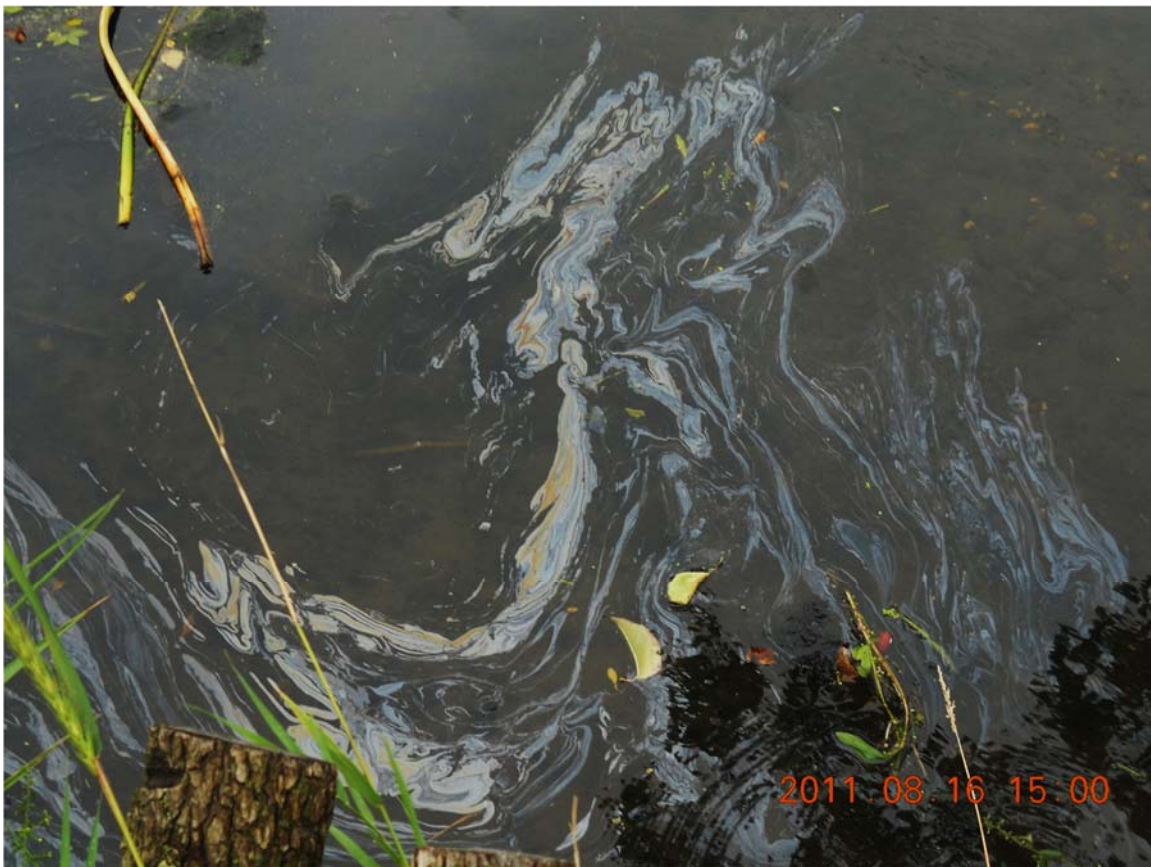
28. MP10.75 sheen observed.
